**ALPHA FOUNDATION FOR THE IMPROVEMENT OF
MINE SAFETY AND HEALTH**

Final Technical Report

Project Title: Operational Sensitivity of Through-The-Earth Communication

Grant Number: AFC113-14

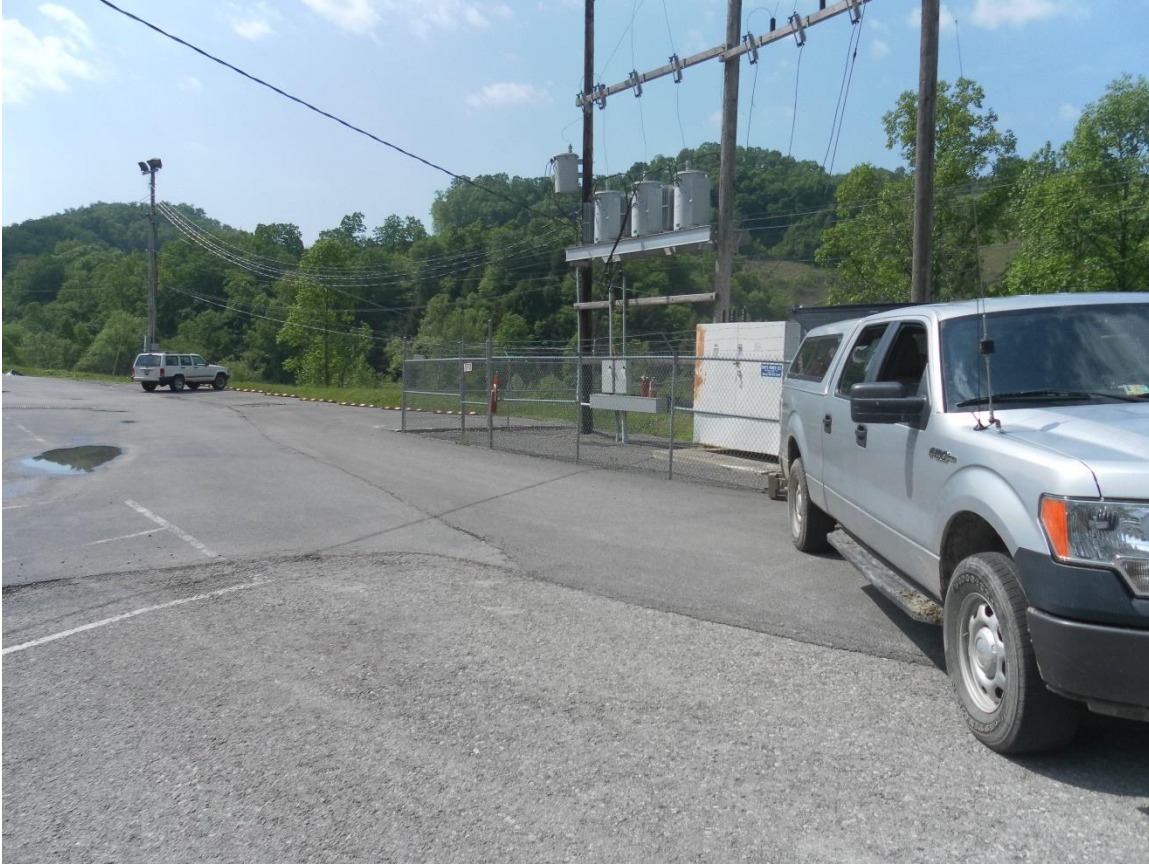
Figure 5. Site A anomalous region in which all MCS communications were prevented.

An anomaly, caused by some unknown variable, was observed within a square shaped area located approximately 60 m (200 ft) laterally along the surface from UGAS 1. The reception of any signal from UGAS 1 was prevented in this zone regardless of the distance between the transmitting MSU and the receiving MGU. This area was situated between the main mine fan and a high voltage transformer as well as underneath several high voltage power cables. A picture of this area is displayed in Figure 5. The lack of signal was confined to the internal area of this region. Any points surveyed outside the square shaped zone produced clear messages from UGAS 1. No other interference of this nature was observed around other substations or power lines at this field site.

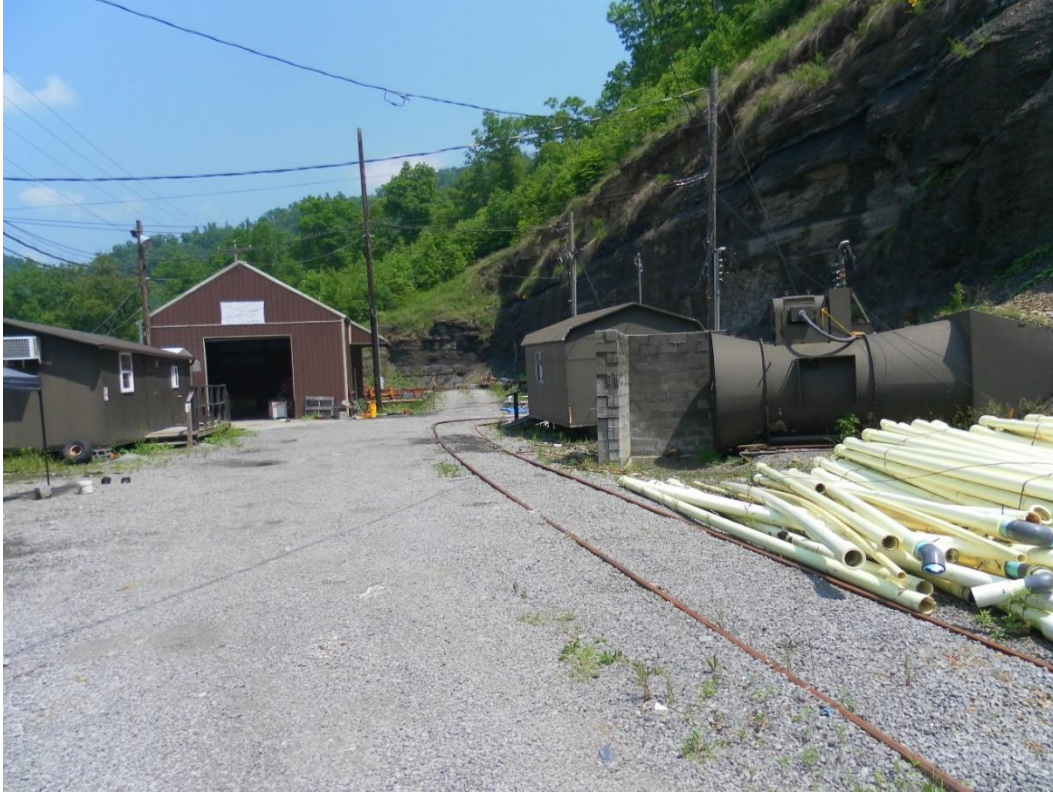
Figure 9. Picture of the rail at the overlying mine portal.

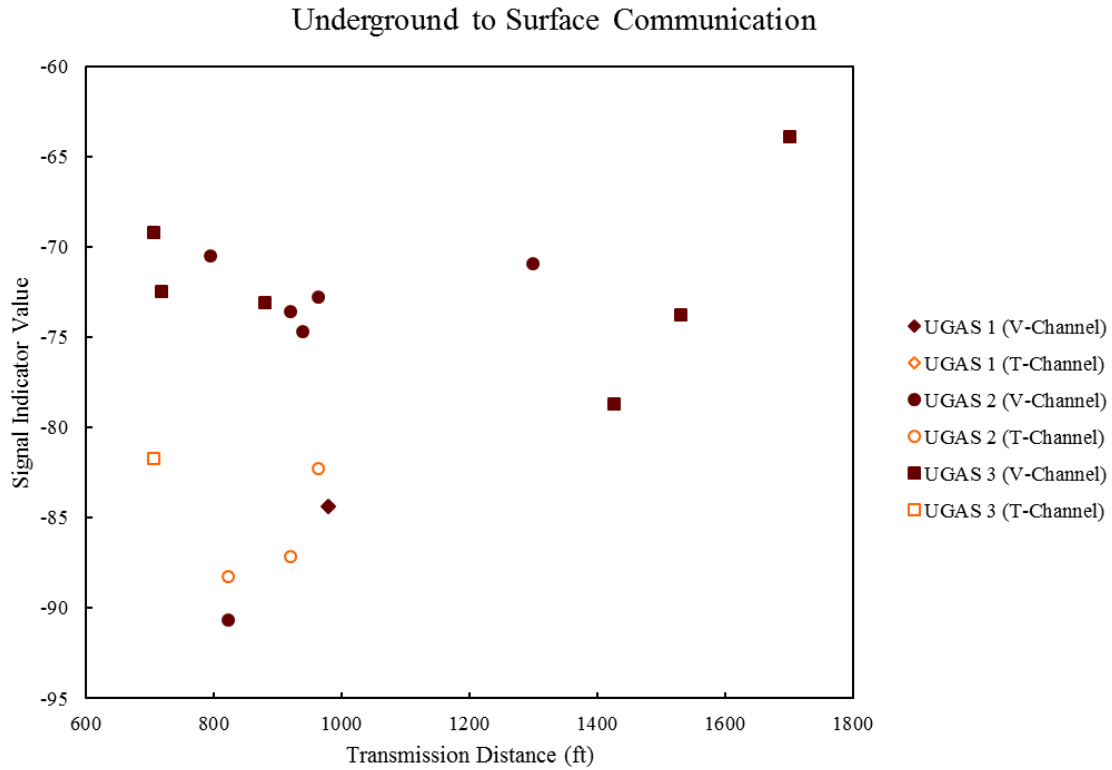
Figure 12. Signal indicator value of the underground to surface traverses as a function of transmission distance from the transmitting antenna.

UGAS 3 was located near the bottom of another well located 160 m (530 ft) from UGAS 2. The entire length of the loop antenna was laid out around a pillar at this location. From UGAS 3, underground to surface communications could be received up to a distance of 470 m (1,500 ft) using the V-channel. Only a single T-channel message was received at a distance of 210 m (700 ft). An errant but clear text was also received at a distance of 520 m (1,700 ft) on the V-channel. Text clarity began to deteriorate at signal indicator values less than -73. Messages could no longer be received at signal indicator values less than -85. The results of these surveys are summarized in Figure 12 and in Table 12.

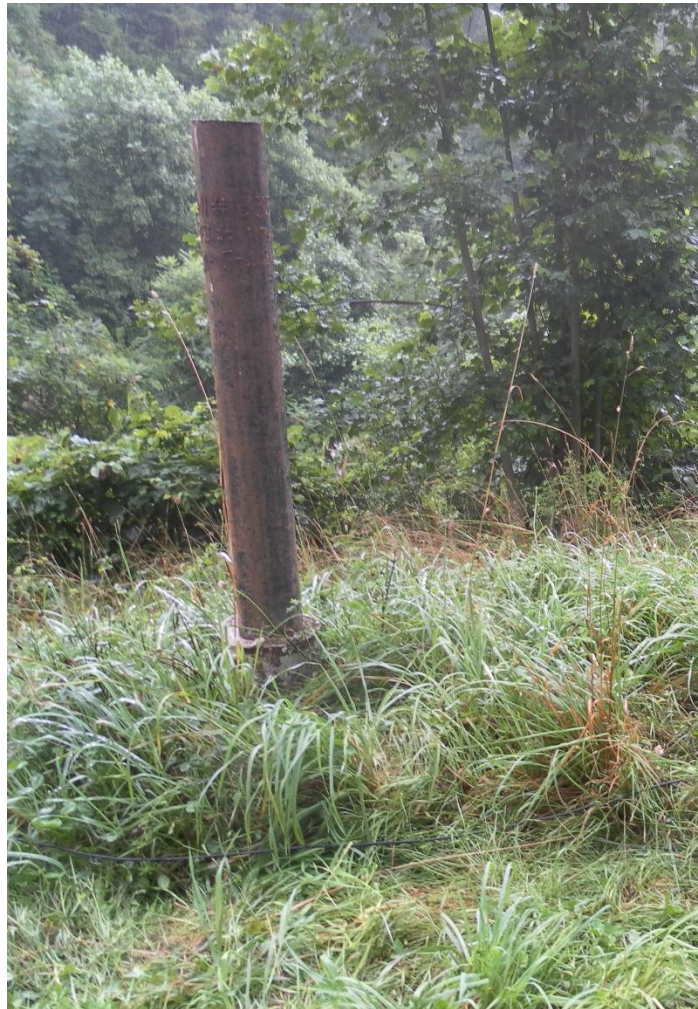
Figure 16. Intact gas-oil well casing from Field Site B.

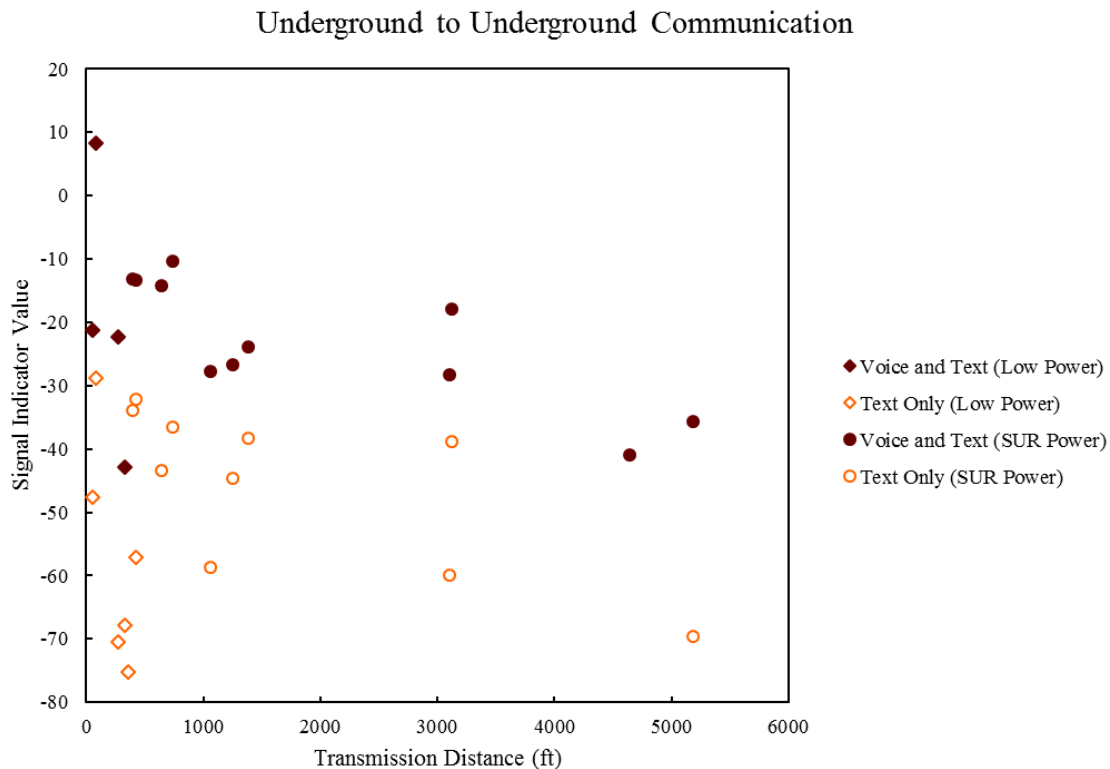
Figure 19. Signal indicator values from underground to underground traverses as a function of transmission distance from the loop antenna.

UGAS 4 was utilized again for underground to underground testing using the elevated transmission power of the MSU. From UGAS 4, the elevated transmission power produced underground to underground transmission distances along the rail up to a distance of 5,200 m (17,000 ft) on the V-channel and 3,100 m (10,000 ft) on the T-channel. Text clarity did not deteriorate on either channel. Messages were abruptly lost when the extent of the transmission range was reached at signal indicator values less than -60. The results of these surface to underground surveys are summarized in Figure 19 and in Table 14.

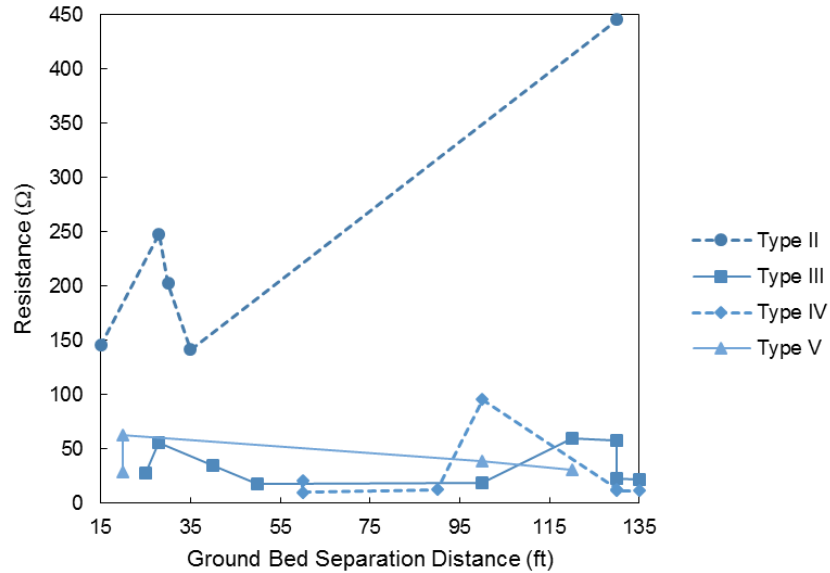
Figure 22. ECS resistance as a function of ground bed separation distance by underground antenna configuration type. Configuration types that did not successfully transmit or receive any messages are not displayed.

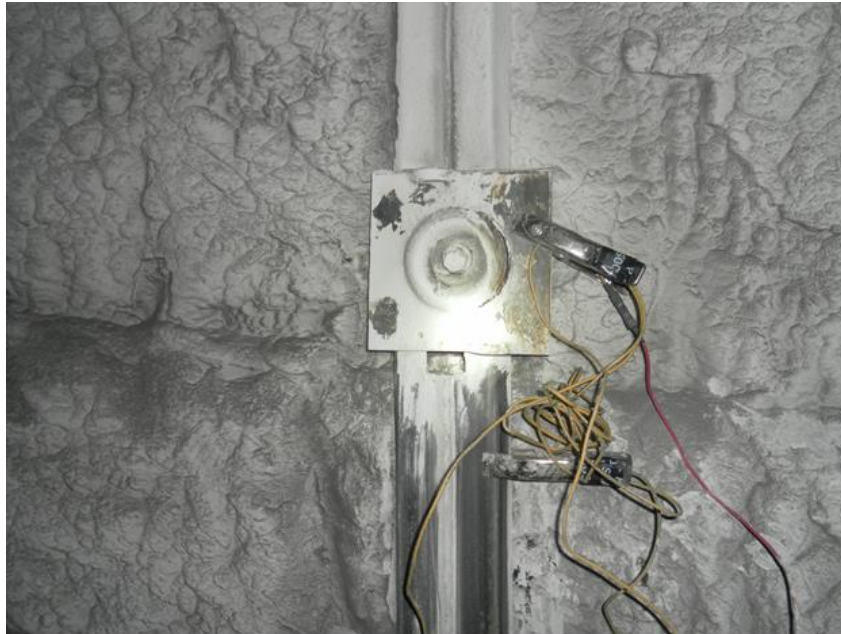
Figure 29. Underground 1.2 m (4 ft) friction fitted copper grounding rods.

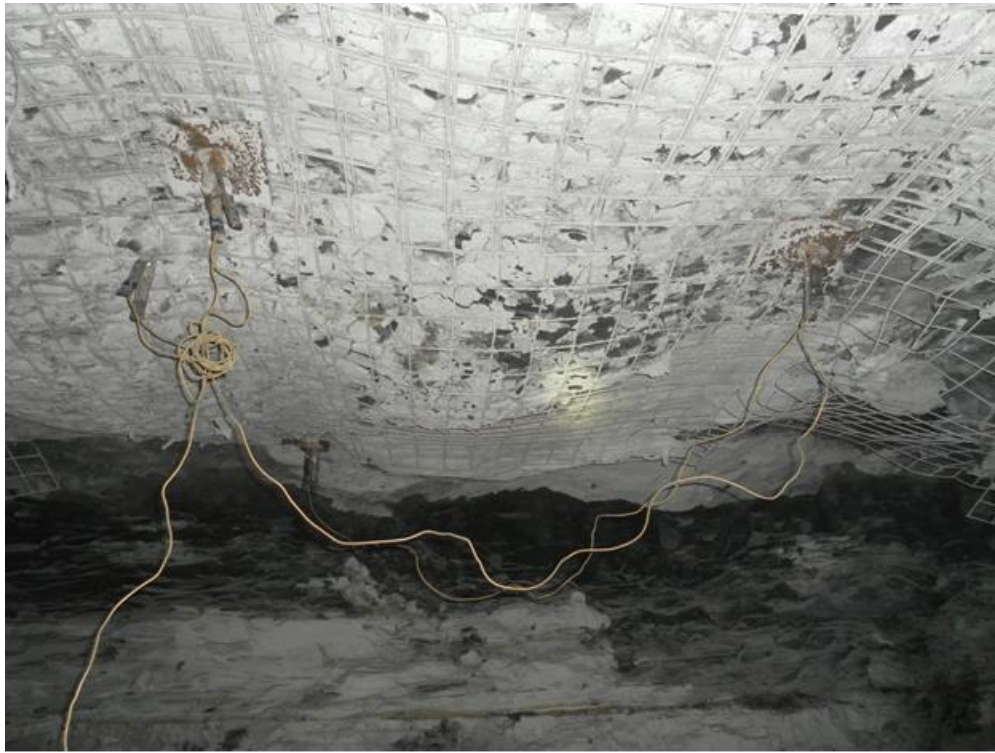
Figure 30. Underground 2 m (6 ft) fully grouted resin bolts.

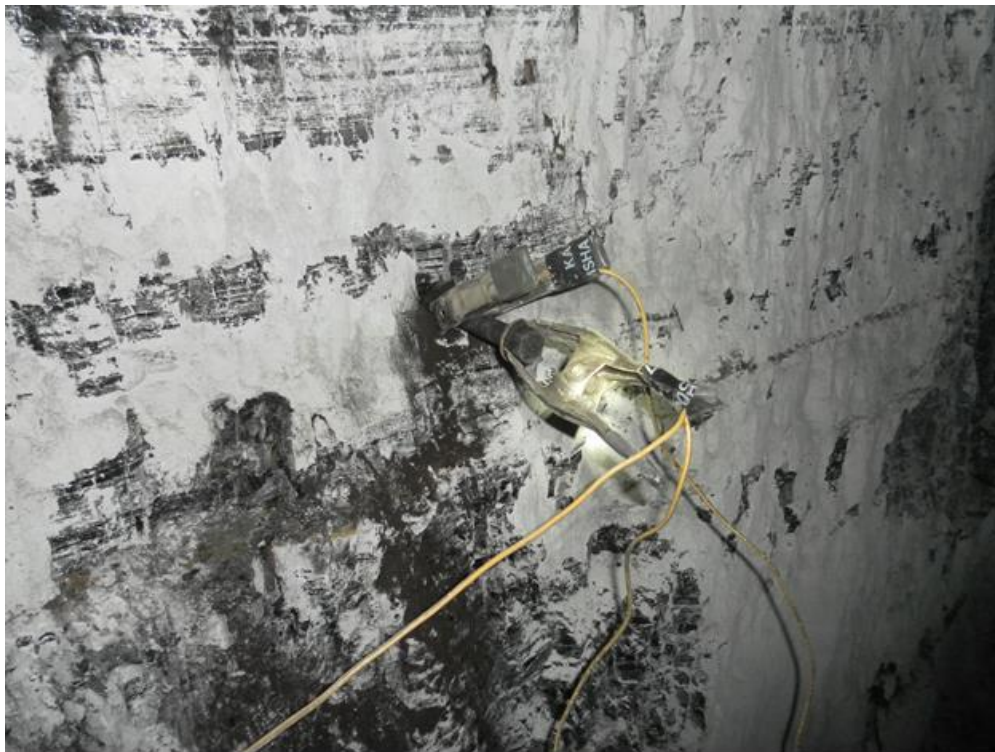
Figure 31. Underground 1.2 m (4 ft) friction fitted steel rib bolt.
