**ALPHA FOUNDATION FOR THE IMPROVEMENT OF MINE SAFETY AND
HEALTH**

Final Technical Report

Project Title: Analysis of Coal Mine Seal Integrity from Explosively Driven Projectiles

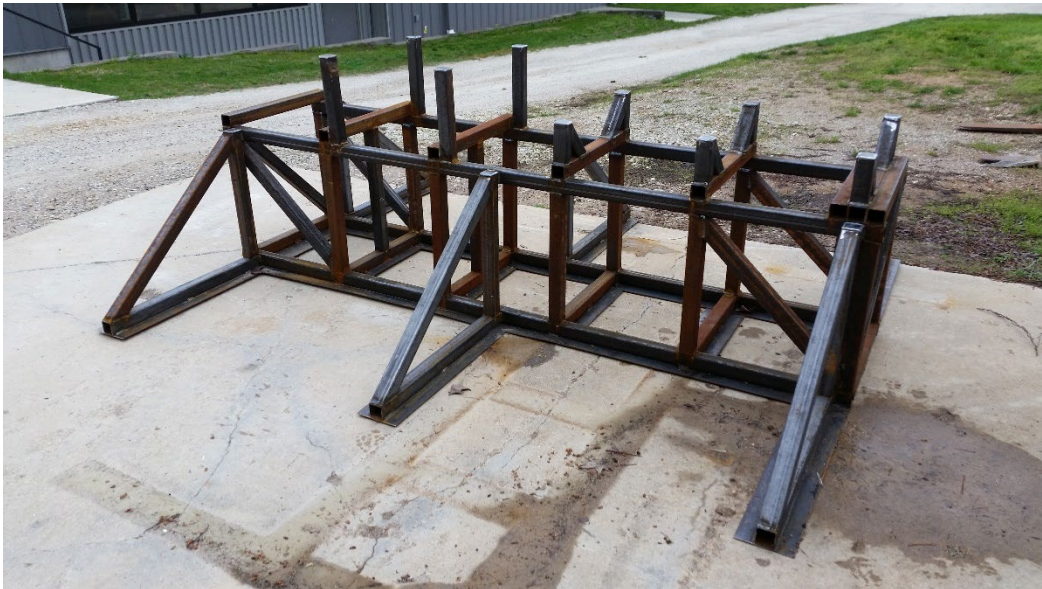
Figure 3.2. Frame During Construction

Construction of the projectile generator was carried out at S&T's Rock Mechanics building. Researchers assembled and welded the frame, shown in Figure 3.2. Outriggers were attached to provide stability during firing, and angled roll-stops (seen on the top right portion of the frame) were added for increased safety (Steward, 2020).

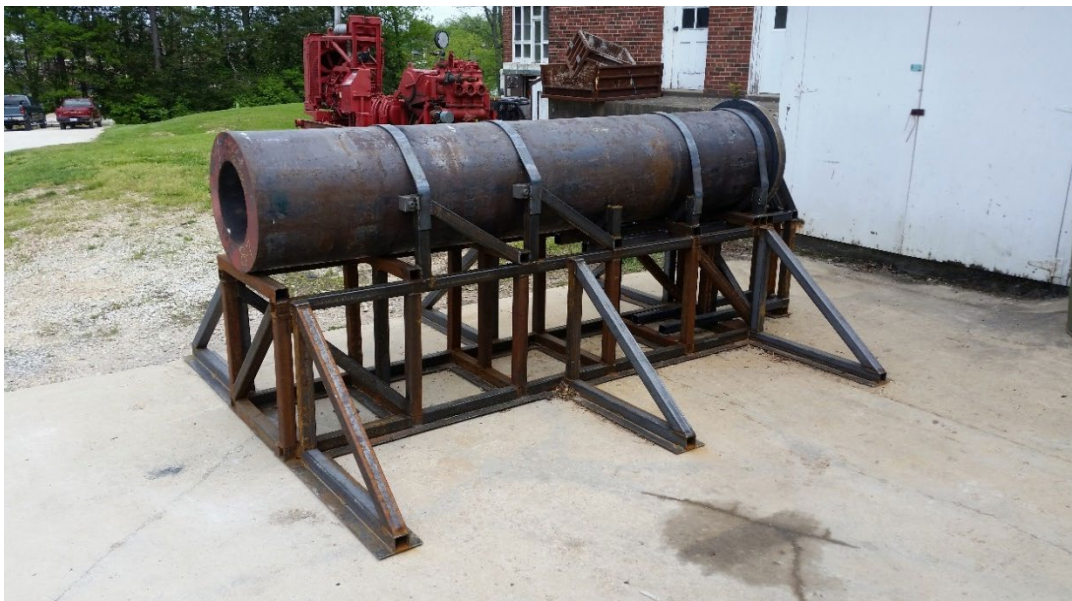
Figure 3.6. Completed Projectile Generator

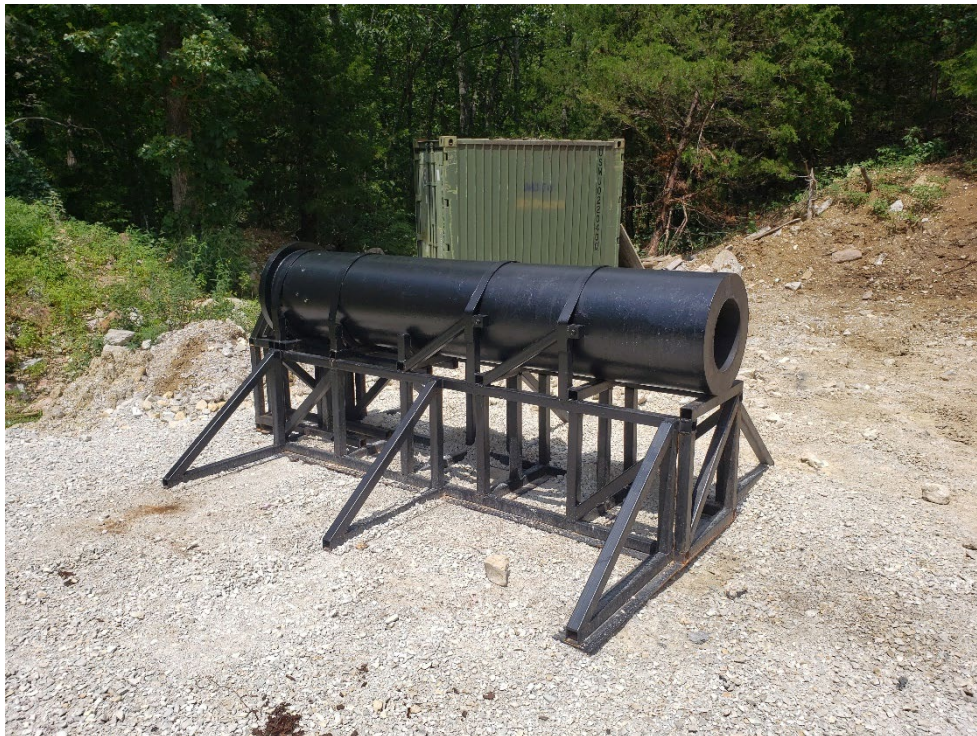
Finally, the projectile generator was placed in position at the test site as shown in Figure 3.7. The projectile generator was specifically designed to fire almost any projectile that fits within a 12-inch diameter circle. To that end, researchers decided on a design very similar to a shotgun wad system in which a wooden “wad” or disk is used to seal the bore during firing and propel projectiles down the barrel. Wads were originally disks cut off from a wood utility pole and lathe turned to the bore diameter, but they were often too cracked along their axis to create an effective gas seal and weighed up to 10 lbs. by themselves. Researchers then used a water jet cutting CNC machine and a CNC router to cut plywood disks which were stacked together and glued to create the wad. This method worked well, obturating the bore and holding together during firing; it also cut the wad weight significantly, allowing higher velocities for the same weight projectile. However, plywood wads shattered in the bore when fired with more than two pounds of black powder due to the increased pressure. Testing determined that charges over two pounds became cost inefficient (due to only moderate velocity gains for additional powder), so researchers used plywood wads and only 1 lb. of powder for all subsequent testing (Steward, 2020).

Figure 3.7. Projectile Generator at Test Site

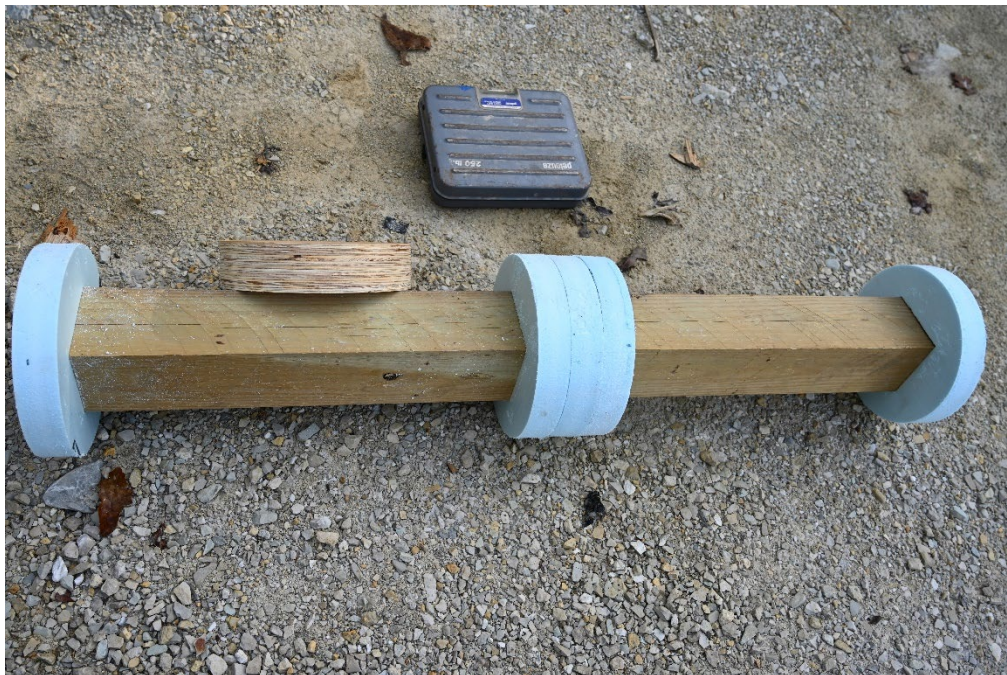
Researchers constructed and fired a wide variety of objects and materials at the three mine seals. These tests included the firing of the following: 5x5 inch five-foot-long wood beams, 30 lb. concrete slugs, four roof bolts plates in a sabot, four roof bolts in a sabot, various hand tools, a section of narrow gauge mine rail, and ten-, twenty- and thirty-pound steel penetrators (Steward, 2020). Figures 3.8 through 3.15 display these projectiles. Projectiles that experienced only surface level damage on impact (all steel penetrators, roof bolts, and the mine rail replaced once) were re-used during testing, all other tests were shot with previously unfired projectiles.

Figure 3.8. Wood Beam

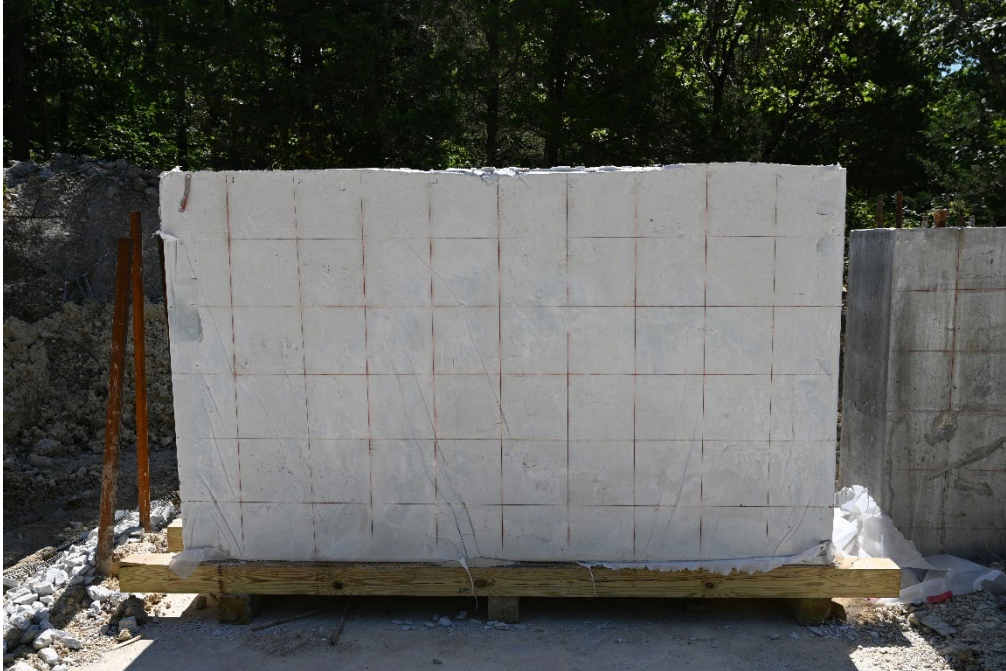
Figure 3.18. Unreinforced Pumpable Cementitious Seal

Figure 3.17 displays the general test setup. Figure 3.18 shows the unreinforced pumpable cementitious seal in place for testing, still on its wood shipping frame. Figure 3.19 displays the layout of the strain gauges on the back of the seals. Figure 3.20 is a video still of a calibration shot fired through the chronograph.

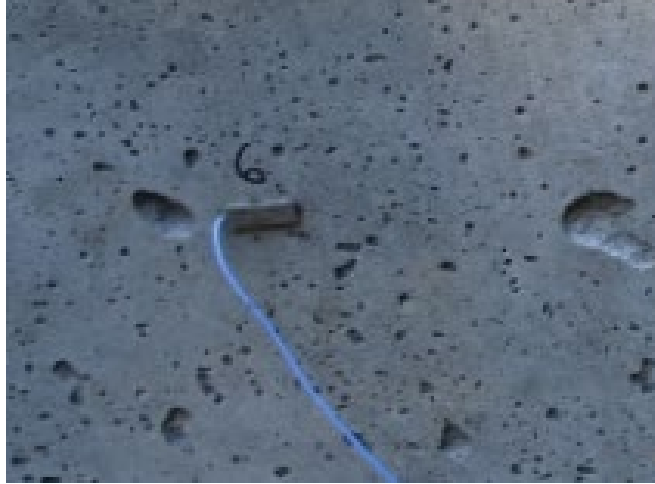
The strain gauges used in this research were Model 740B02 from PCB Piezotronics. These were selected for their very fast response rate which allows for a high sampling rate which is necessary in a dynamic system like projectile impact. The sensors are only 0.6 inches long, 0.2 inches wide, and 0.07 inches thick. The rear face seal surface was checked for material integrity and any loose material was removed. The gauges were applied using a high strength epoxy provided with the gauges. A sample of the strain gauge installation is shown in Figure 3.21. The strain gauges are designed to be reusable upon removal and relocation. However, a couple strain gauges were damaged (cable detachment) when removing them from the seals and were replaced. Each gauge comes with a unique serial number and calibration sheet which was used to convert from recorded voltage to microstrain.

Figure 3.21. Strain Gauge on Rear Face of a Seal

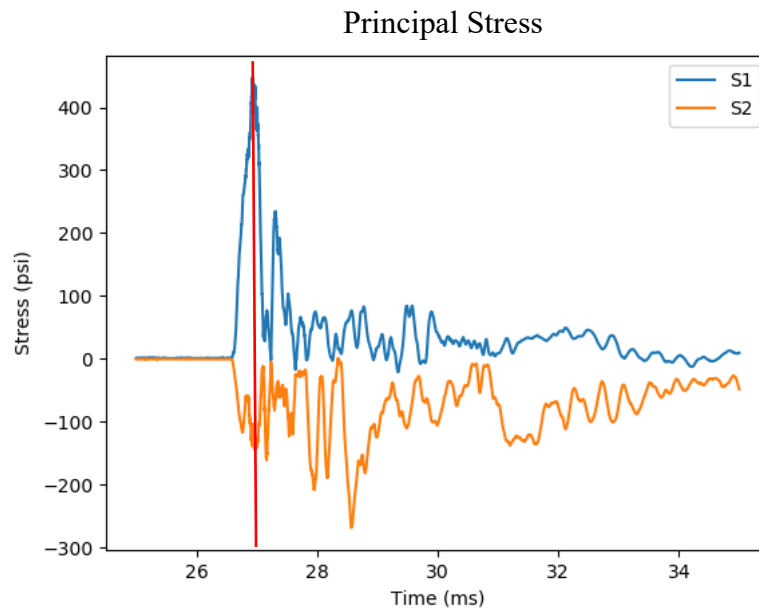
Figure 3.23 shows an example (30lb concrete on Reinforced Concrete seal) of the principal stress graph produced from the calculations and implementation of Hooke's law to convert strain to stress using the modulus of elasticity. The blue line (positive) indicates tension while the orange line (negative) is compression. Of most interest from this graph is the maximum tensile principal stress since concrete is weakest in tension. Therefore, the principal stresses were tabulated at the time where the tensile principal stress was at its maximum along with corresponding compression at the same time (shown as the red vertical line in Figure 3.23). Additional information and raw data can be found in the Appendices of this report.

Figure 1.23. Principal Stress Derived from Strain Rosette.

Elastic response was assumed in the calculations since damage was minimal or non-existent on the rear face where the strain gauges were installed, and recordings of each gauge returned to their approximate initial values (within the noise level) after the seals returned to equilibrium after impact.

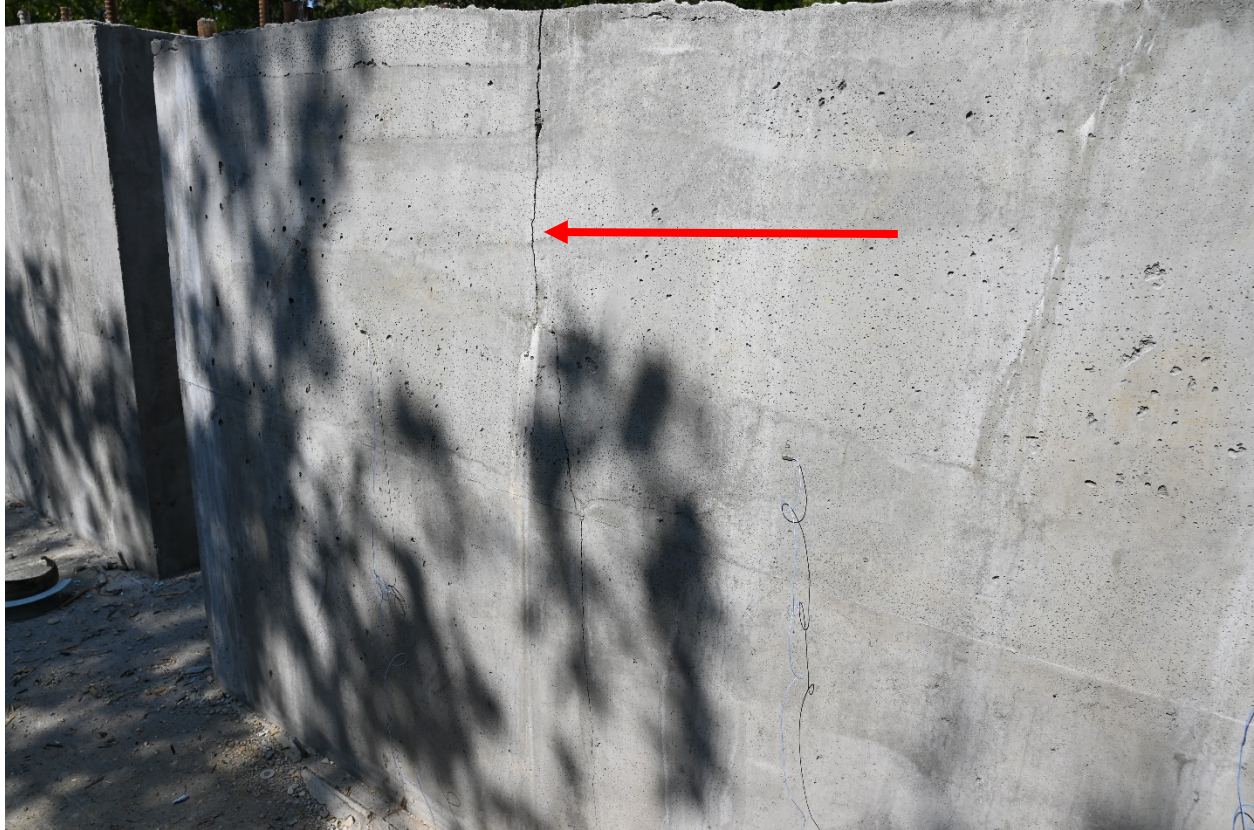
Figure 4.4. Crack on Rear Surface Extending Down from the Top

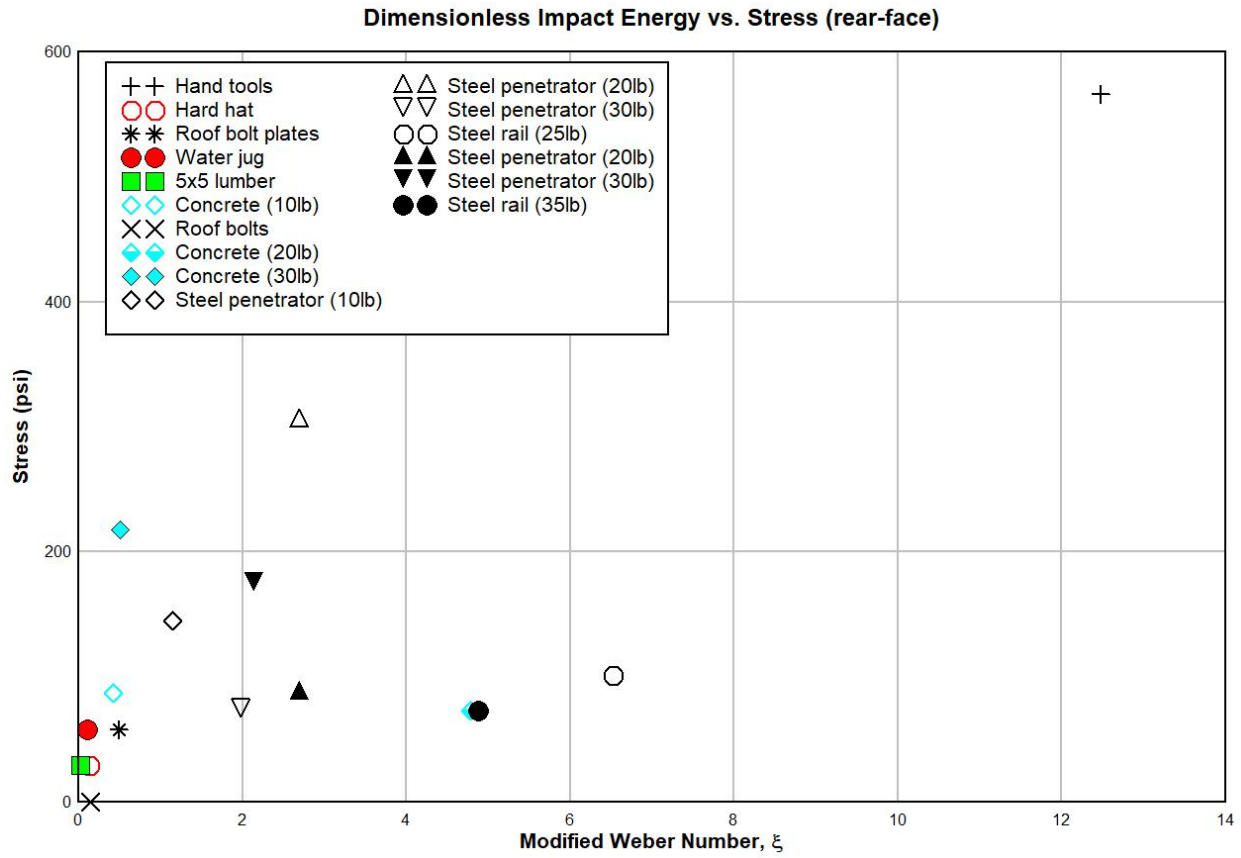
Figure 4.5 is a graph displaying the relative impact energy (x axis) vs rear face stress in PSI (y axis). The stress was derived from the strain gauge rosette at the center of the seal. The modified Weber number (x axis) is a dimensionless parameter used to compare impact parameters across projectile types which incorporates projectile and target properties. The original Weber number is typically used in fluid mechanics and is a ratio of the internal penetrating force to surface tension force. When boiled down, the modified Weber number is a ratio of the kinetic energy of the projectile and the surface energy of the target with a larger number indicating more likelihood of penetration (von Niederhausern 2019). An interesting result of this analysis is that the concrete 30 lb. projectile had lower relative impact energy and did no surface damage but caused more rear-face stress than the 30 lb. steel penetrator, which removed a large portion of the seal entirely. This significant result will be compared to similar findings in the reinforced concrete seal and is discussed in greater depth by von Niederhausern (2019).

Figure 4.5. Graph of Unreinforced Concrete Seal Stress vs Impact Energy (adapted from von Niederhausern, 2019)

Due to this type of experimental testing, there are several considerations when evaluating Figure 4.5. Strain gauge location (Figure 3.19) was consistent throughout testing of the seal but impact location varied for each projectile in an attempt to impact a “clean/fresh” face. Therefore, some impacts may have been directly opposite of a gauge or the rosette while others were not. Progressive damage is also likely to effect true measured values. For example, the 30-pound steel penetrator which completely removed a corner of the seal (Figure 4.1) shows a lower stress than the first 20 pound steel penetrator test. Not only was the final 30-pound projectile fired toward the end where there were no strain gauges directly on the opposite side, but there were three additional

tests between those two which had heavy steel projectile impacting the seal. Progressive damage generating and extending cracks may have created an energy sink not allowing a direct path toward the strain gauges near the middle of the rear face of the seal. Additionally, energy going into complete separation and movement of the detached seal material reduced the amount available to get to the strain gauges.

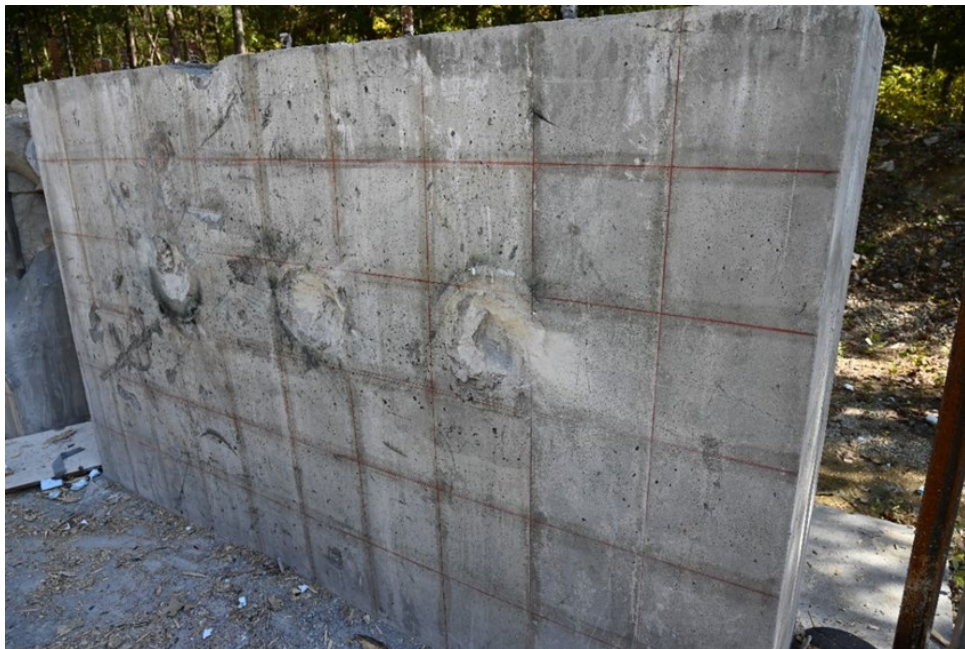
Figure 4.6. Reinforced Concrete Seal, Post-Test

Table 4.2 presents the projectile data. Figure 4.6 shows the final state of the reinforced seal after all testing was complete. The 10 lb. steel slug impacted on the left, the 30 lb. in the center, and the 20 lb. on the right. The 10 lb. slug impact site exhibited slightly less damage than the others, its penetration and crush zone were significantly less. Both the 30 and 20 lb. slugs penetrated deeper and had wider crushed and cracked zones, with the 20 lb. slug leaving a slightly deeper cavity (Steward 2020).

Impact locations are shown in Figure 4.8 (locations are approximate for the tools, roof bolts, and roof bolt plates). The 30 lb. impact site is the middle crater in Figure 4.6 and Figure 4.7; all sites exhibited similar characteristics with a crush zone, a heavily cracked and partially ejected zone, and some small but long cracks going towards free faces. Most of the material in the crushed zone was ejected during impact. The heavily cracked zone extended about an inch outside the crush zone and was also missing some material that was ejected or fell off the seal after impact. Though far less cracking occurred outside of these zones as compared to the unreinforced seal, researchers observed some small cracks traveling between the impact sites and from the impact sites to the edges of the seal. Some very slight cracking was also observed at the rear of the seal. No major failures or large cracks were observed during any of the tests and the reinforced seal did not fail as the unreinforced seal did (Steward 2020).

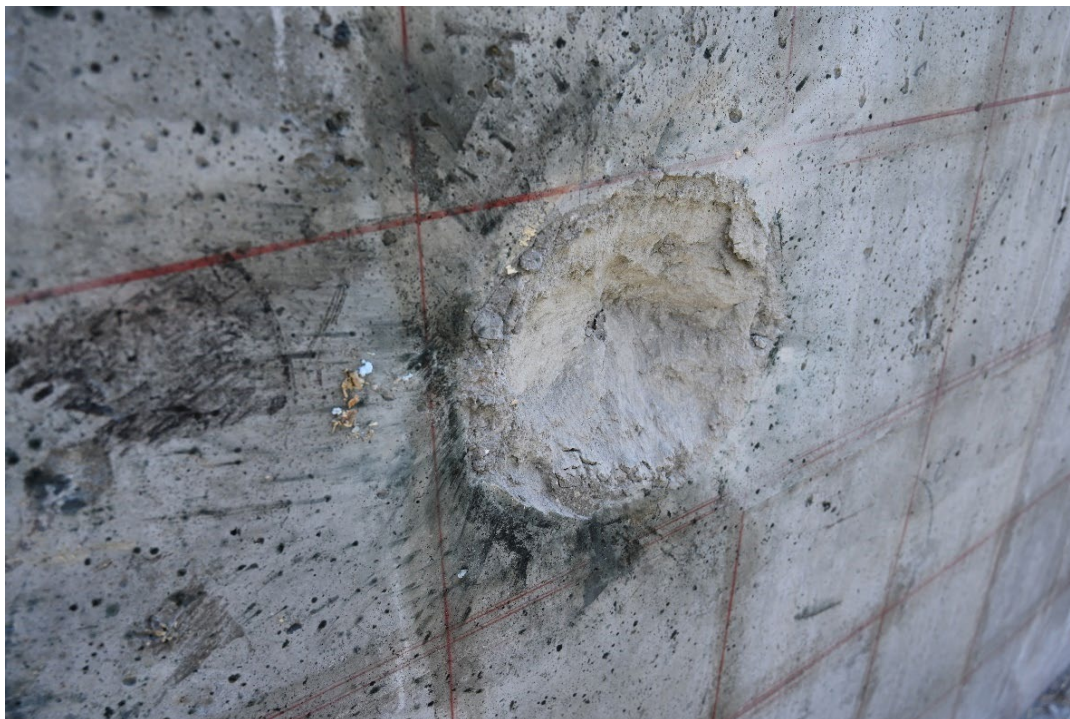
Figure 4.7. 30 lb. Steel Slug Impact Site

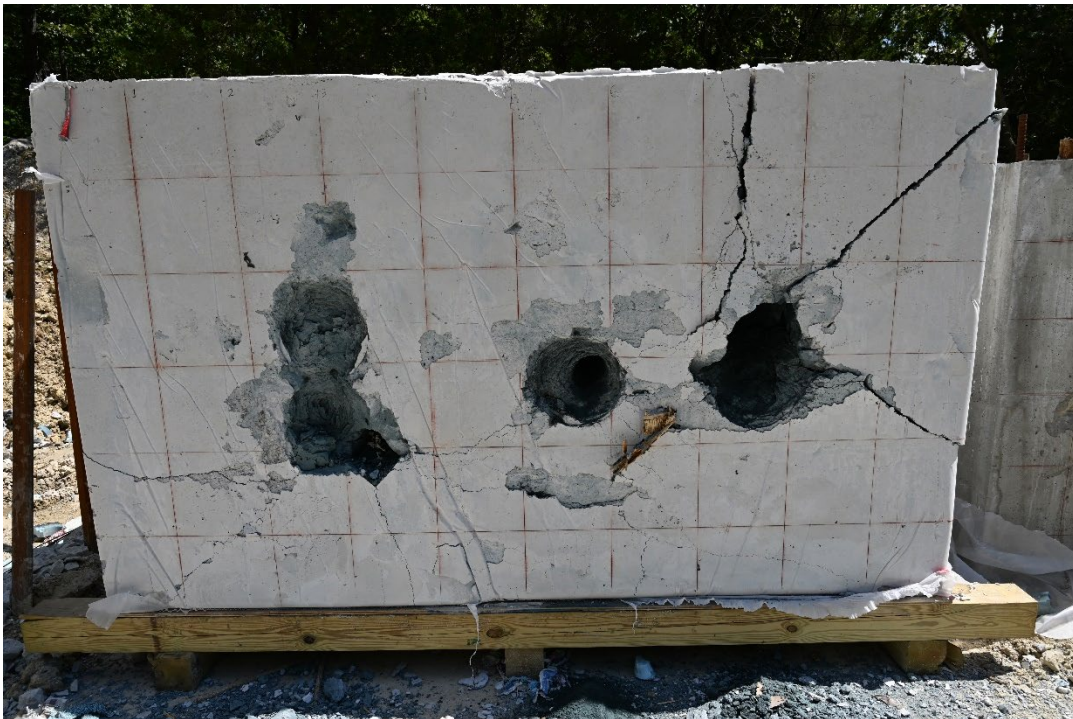
The unreinforced pumpable cementitious seal experienced catastrophic failure, extensive cracking, ejection and destruction of a large amount of seal material, and a penetration equal to about 66% of its thickness. Only four projectiles were fired at this seal before it was deemed too damaged to yield any more meaningful results from further tests: a wood 5x5 inch beam, hand tools, a 30 lb. concrete slug, and a 20 lb. steel penetrator. Figure 4.10 displays the damage to the seal after the four tests. Figure 4.11 shows the projectile impact locations. Velocity data is presented in Table 4.5.

Figure 4.10. Unreinforced Cementitious Seal, Post-Test

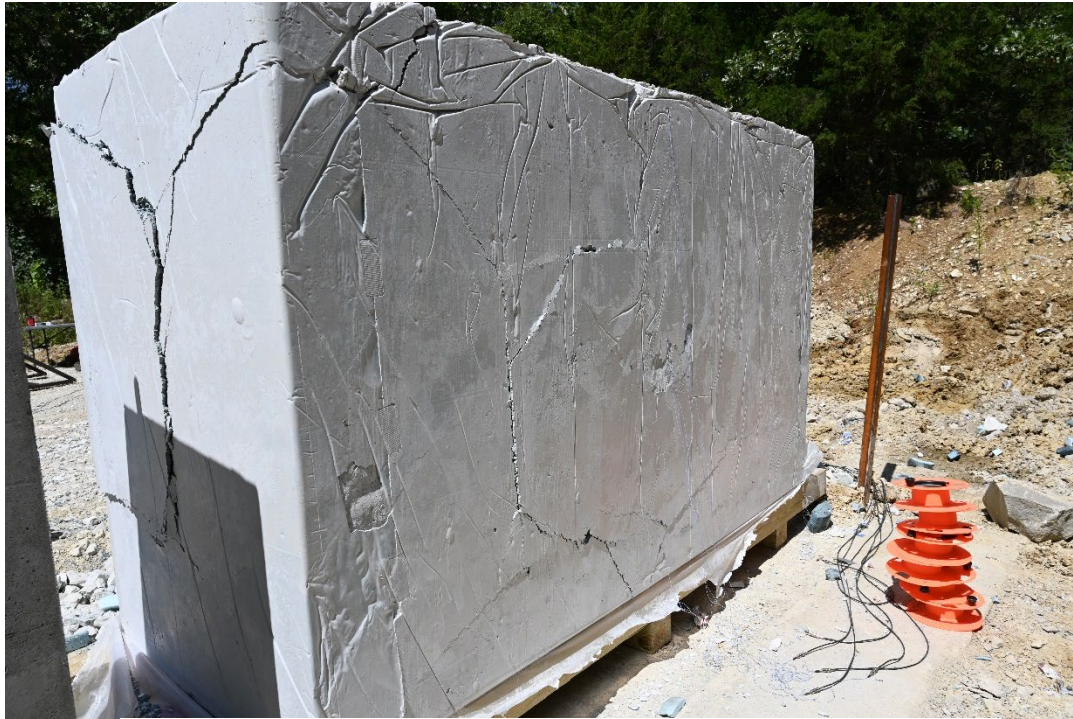
the impact was observed but no major spalling or bulging occurred. Figure 4.12 is a picture of the rear face and right side of the seal, displaying the widespread cracking and fracturing of the seal. Both the concrete and steel projectiles caused several pounds (estimate) of seal material to be ejected on impact.

Figure 4.12. Unreinforced Pumpable Cementitious Seal, Rear

Strain gauge data from this seal did not conform to data from the other two seals; data shows that stress was very low. Considering that the seal experienced widespread crack formation in the rear face, this data is likely erroneous, but has been provided in the appendix for reference. Due to the nature of the pumpable cementitious seal's material (it was soft enough to be scratched with a fingernail) the surface was very easy to deform. The strain gauges were glued to the rear face and the seal material was simply too soft to transmit any significant strains into harder materials like the sensors.

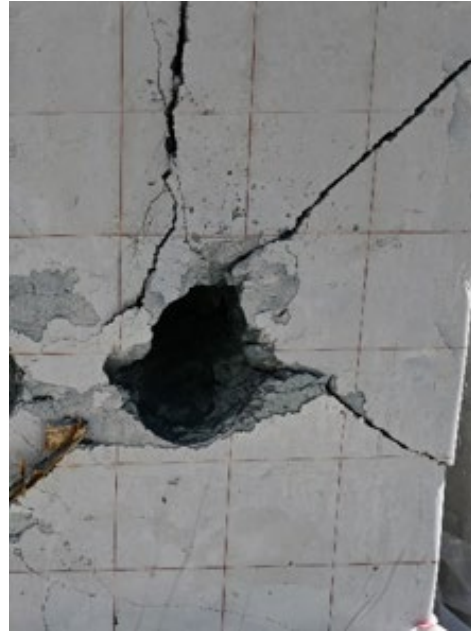
The two Strata seals performed similarly but the Minova seal was notably different. The strength of the material used to construct a mine seal has a significant effect on its ability to resist projectile penetration which can lead to damage. Since the Minova material was relatively soft, strain was not able to be measured on the rear face thereby only allowing comparison of projectile penetration. Table 4.6 shows a comparison of penetration between two different projectile types for the Strata Reinforced Concrete seal which uses 4,000 PSI (minimum) concrete and the Minova Plug seal which uses a 400 PSI (minimum) cementitious material. The performance difference is noticeable as shown in Figure 4.13.

Figure 4.13. 30-lb. Concrete impact comparison between seal material types. Left is harder seal material where concrete projectile is pulverized resulting in no penetration. Right is softer seal material with significant penetration with concrete slug still inside seal.

It must be noted that seals are designed for overpressure design (among other things), not projectiles. Both seals in Table 4.6 and Figure 4.13 are approved by MSHA for overpressure design and there is no current design standard for projectiles.
